### Introduction

Site 1 – Medcalfe Road

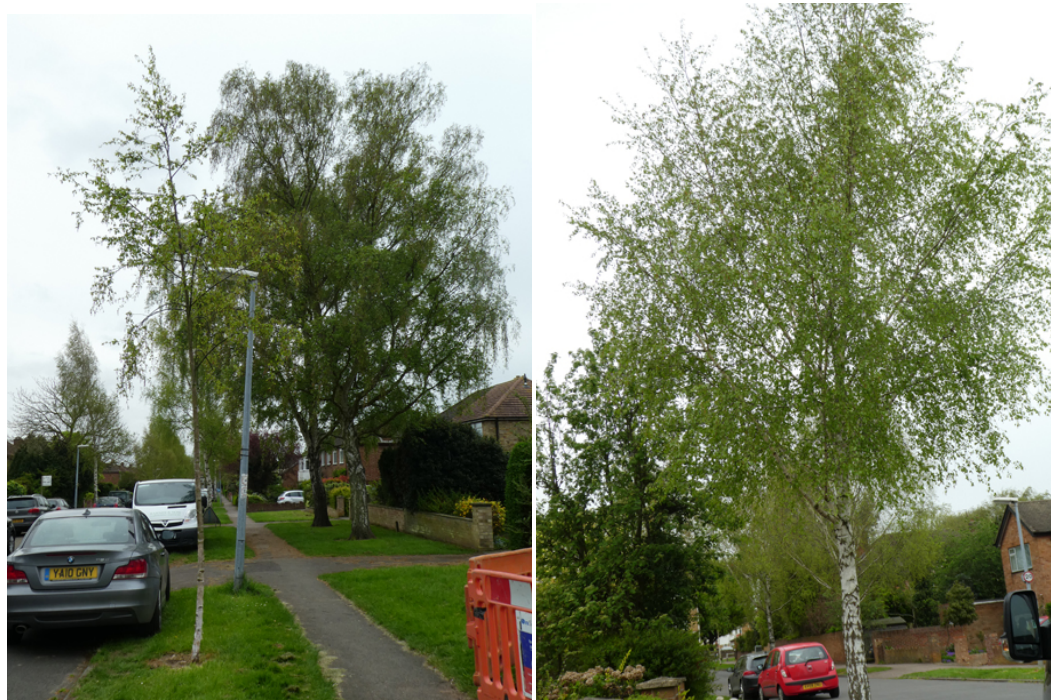
Species viewed Early mature birch

Birches grew well, enriched the soil by fixing nitrogen, were durable (i.e. 80 – max. 120 years), and had low water demand.

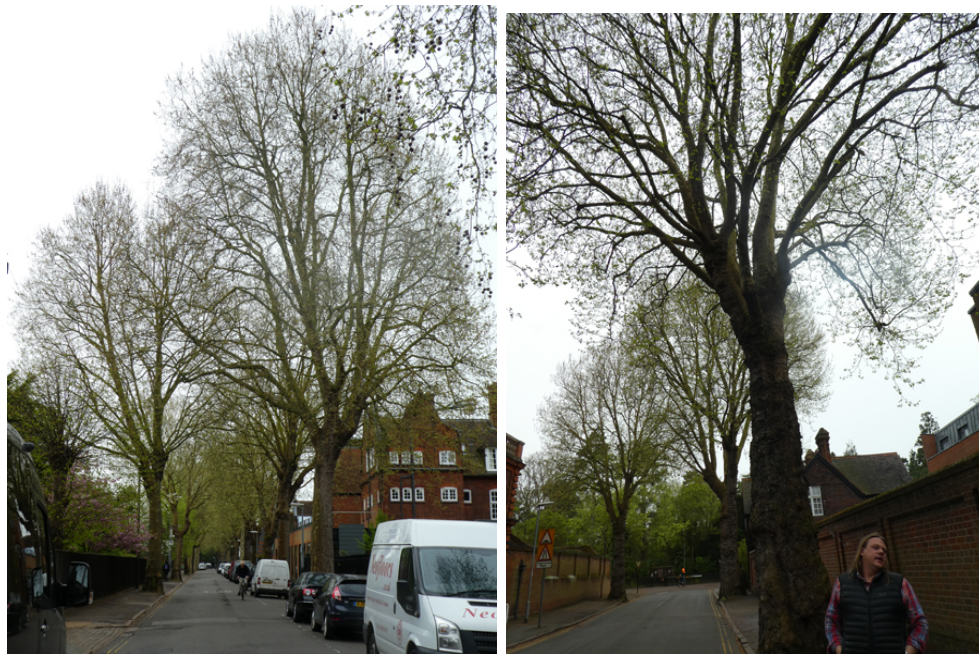
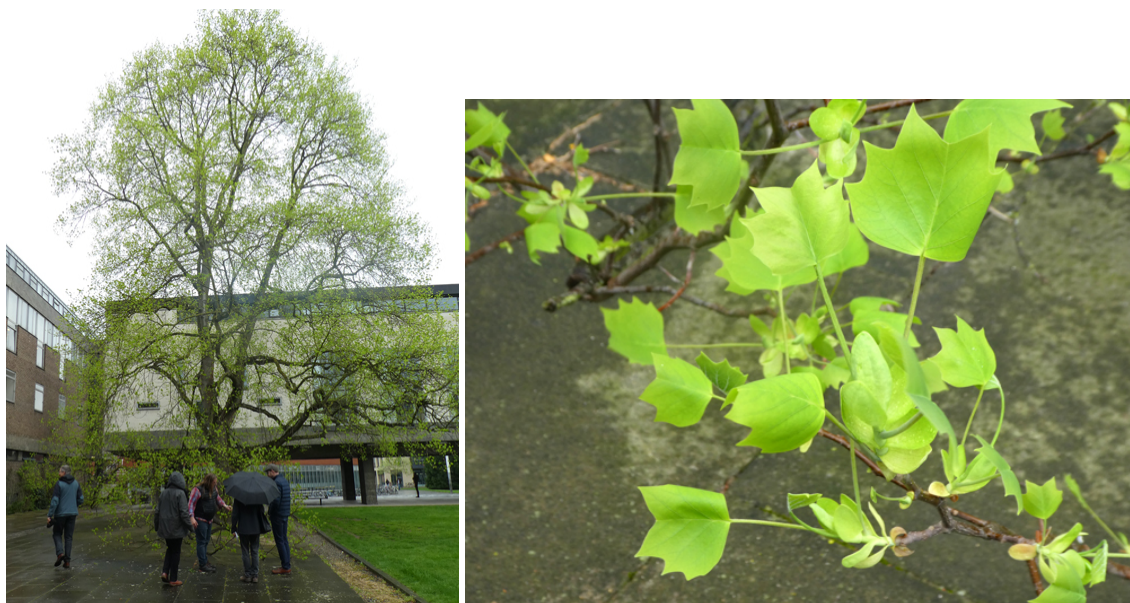
Site 3 – Sidgwick Avenue

Species viewed – Mature London Plane (above) and Tulip Tree (below)

London Plane trees were “bombproof”. Long lasting, surviving pathogens (although some early warning recently reported in Europe), could be pollarded (although this was dangerous to tree surgeons in narrow areas close to roads). In Sidgwick Avenue, roots broke up pavements making problems for push chairs/wheelchairs.

Tulip trees were a suitable choice for larger spaces. Lower branches could be pruned. Robust, pollutant- and heat-resistant. No known pathogens. Less flare at base of trunk than London planes. Quick growing.

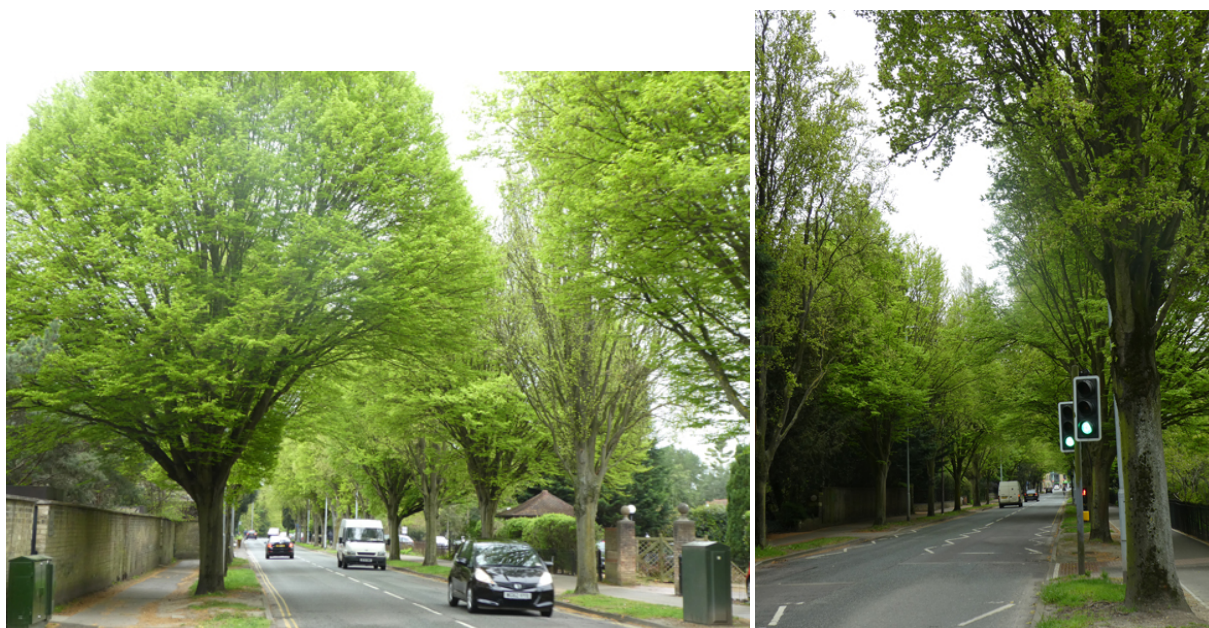
#### Site 4 – Brooklands Avenue

#### Species viewed – Mature Hornbeam and Dawyck Beech

There were some problems with the hornbeams (rust), possibly caused by salting roads in winter. Viewed in tight area i.e. narrow verges. An example of how two different species worked well together. [Together, these two species formed a very dense canopy, which was OK on Brooklands Avenue as properties set far back from trees, but would occlude light from adjacent houses where front gardens are small or absent.]

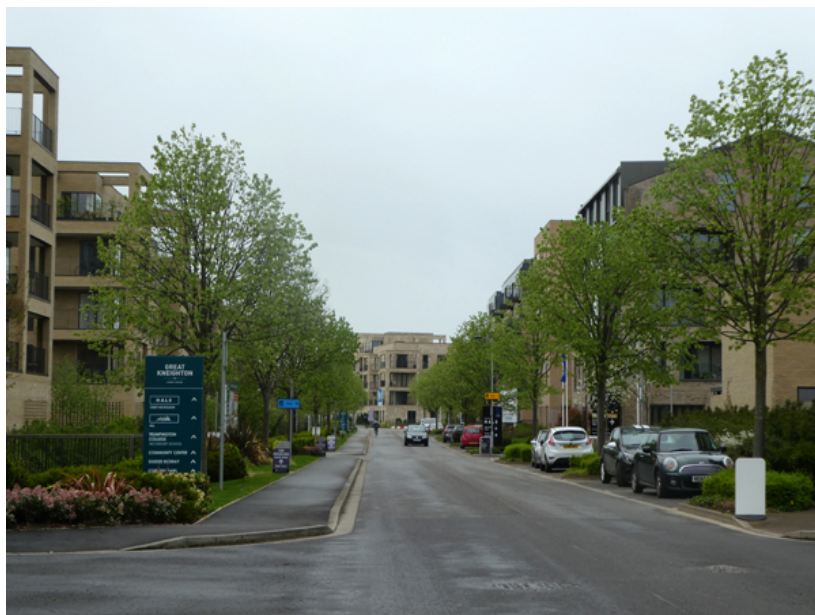
Site 5 – Aura Development in Great Kneighton

Species viewed – Semi-mature Lime trees – small-leaved variety

Very costly with regular maintenance in expensive development area. Survival in other areas would be high risk (KM).

NB. There are varieties of lime trees which do not produce sticky sap, as they have hairy leaves which aphids avoid. [Think these are that variety.]

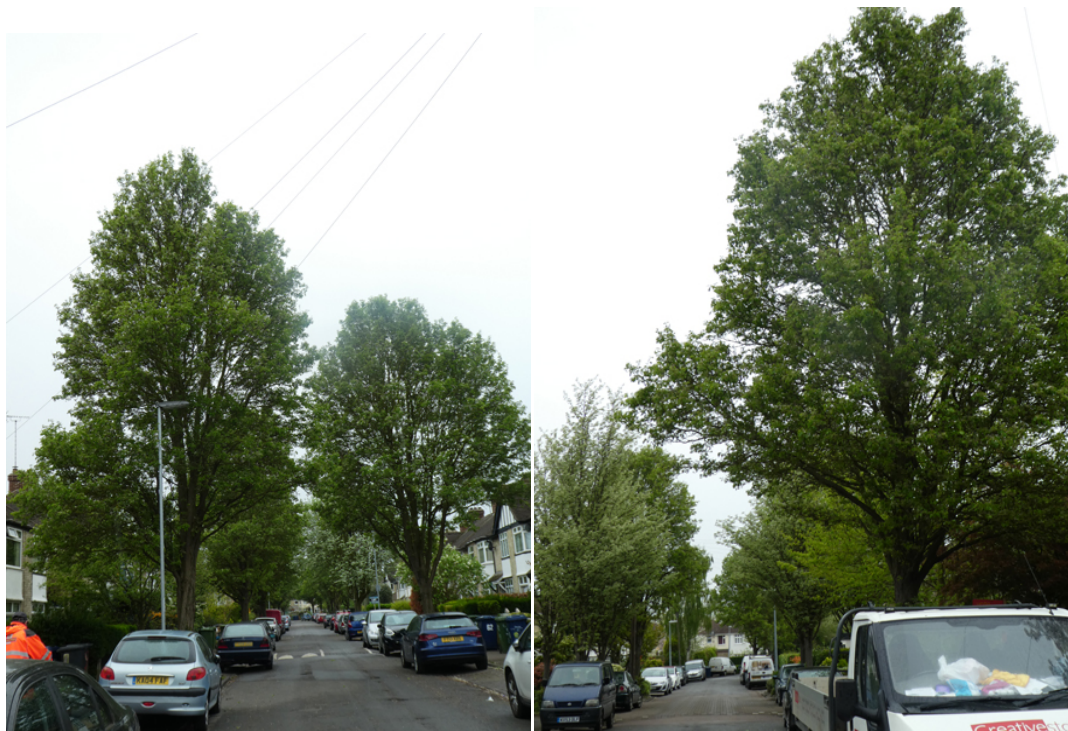
Site 6 – Brampton Road

Species viewed – Pears (Chanticleer), crab apples, whitebeam

Flowering pears conical shape, have flowers and autumn colour, grow in poor sites. Suitable for narrower stretches of Milton Road. Crab apples – problem with mushy fruit on the ground (objections from residents). Whitebeam – tough trees, light coloured leaves, get broad but would be suitable for “break out points” along the road.

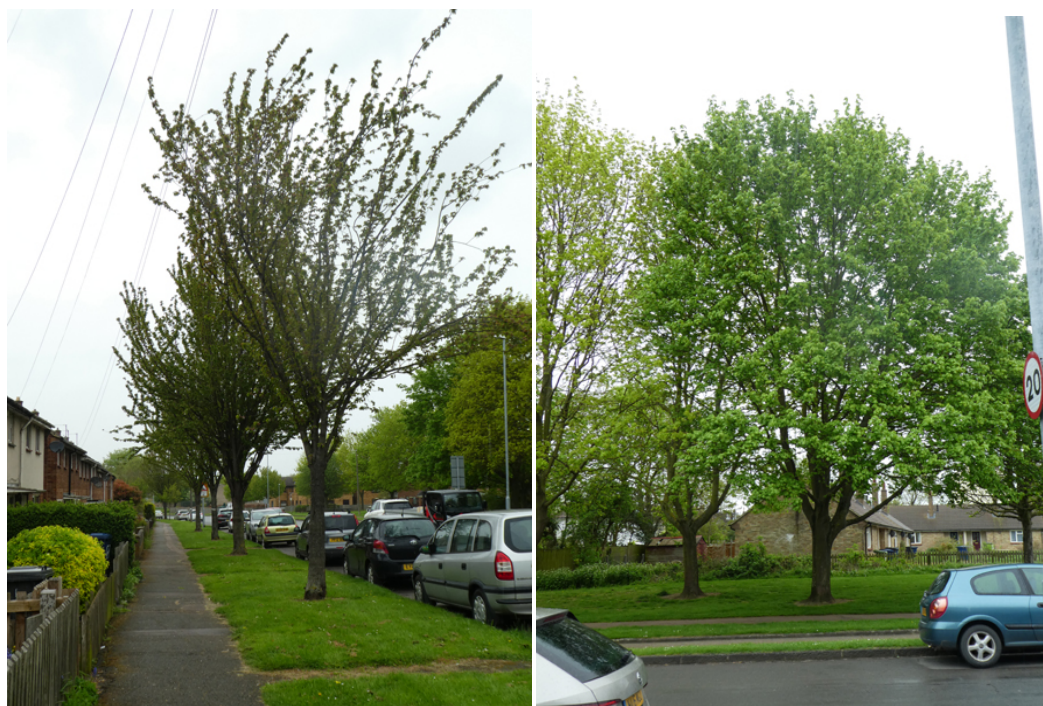
Site 7 – Wadloes Road

Species viewed – mature cherries and field maples

Cherries – upright Y-shaped conical, quite tough, fit in narrow sites. Could use bigger cherry (e.g. *prunus avium*) on corner, say, of a group of larger trees.

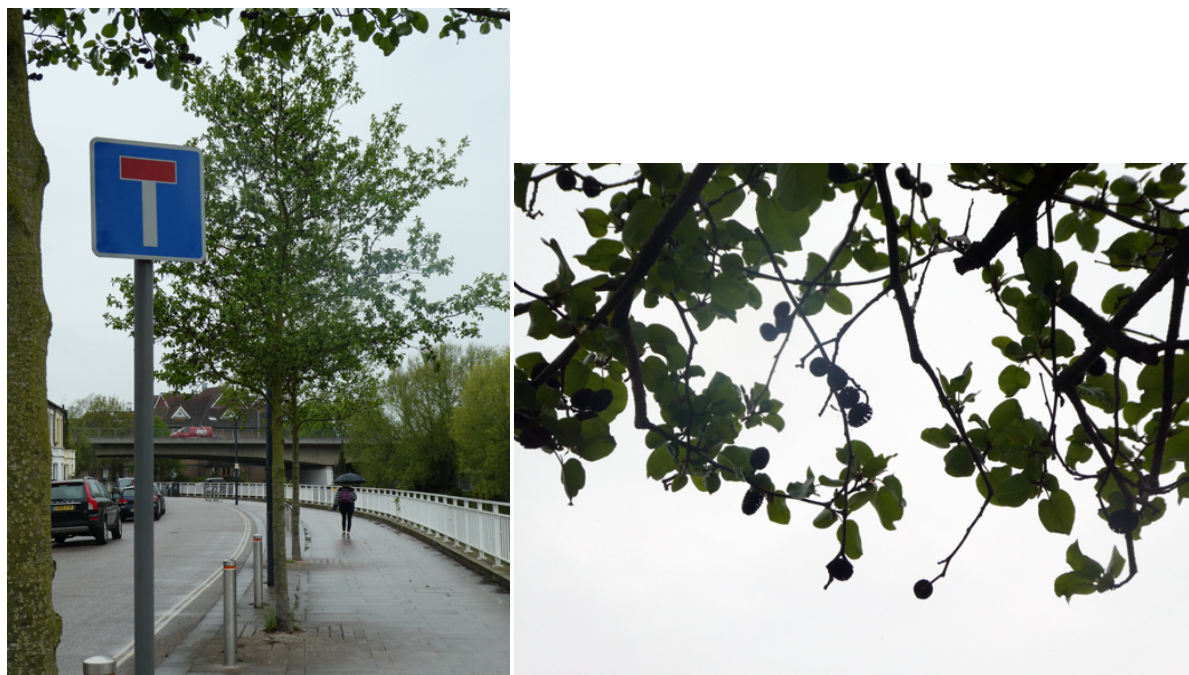
Site 8 – Riverside

Species viewed – Semi mature Italian Alders in rootcell system (i.e. no verge for planting)

Commonly used in urban sites in Europe. Well-behaved trees. Rootcell system effective for providing water needed. Slender with heart shaped leaves. Yellow autumn colour.
